Illinois Commerce Commission

Assessment of Interstate Power and Light Company's

Annual Reliability Report of

For Calendar Year 2002

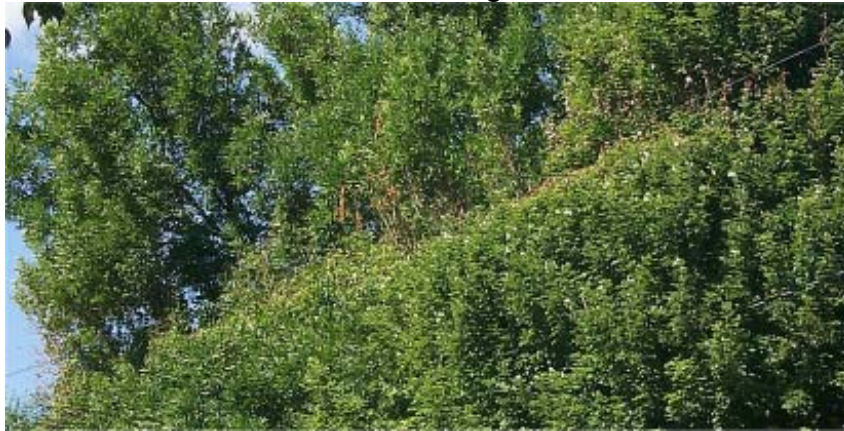
Photo 1

This 13kV circuit, a 2002 worst performing circuit due to SAIFI, serves approximately half of the city of Galena. Of the twenty-five outages on this circuit in 2002, thirteen were weather related, six due to wildlife, and five were unknown or caused by the public. IP&L reported none of the outages as tree-related. IP&L last trimmed this circuit in 1999, and next the next scheduled tree trimming is 2003. IP&L has no additional reliability improvements scheduled for this circuit at this time. Staff found several locations where trees were contacting the primary (Photos 1 & 2). The circuit appeared to have adequate quantities of tap-line fuses, animal protection, and lightning arrestor installations. Staff feels that mid-cycle spot tree trimming would improve the reliability of this circuit. Given that the next scheduled tree trimming is 2003 the number of trees close to or in the primary wires should be resolved at that time. Staff suggests IP&L consider performing an inspection of this circuit and correcting any found problems to ensure that it does not continue to be a worst performer. IP&L last inspected this circuit in 1994.

Conductor burning in trees

Hill & Franklin Streets in Galena

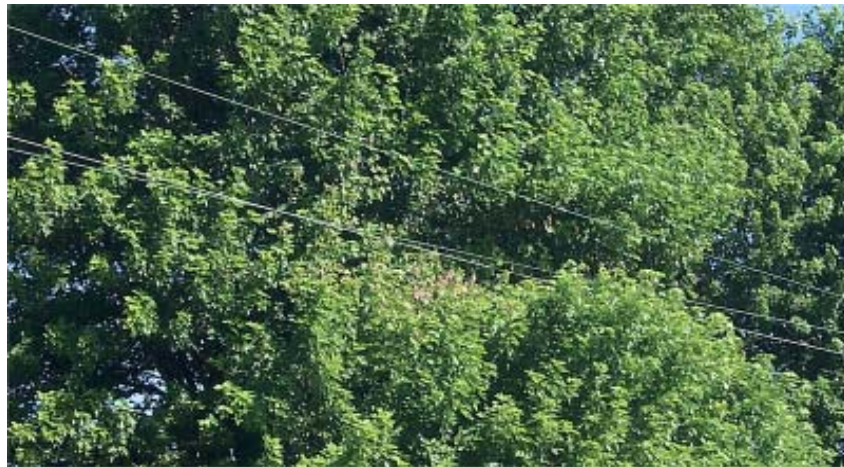
Photo 2

Conductor in contact with trees

On Red Gates Road west of Galena

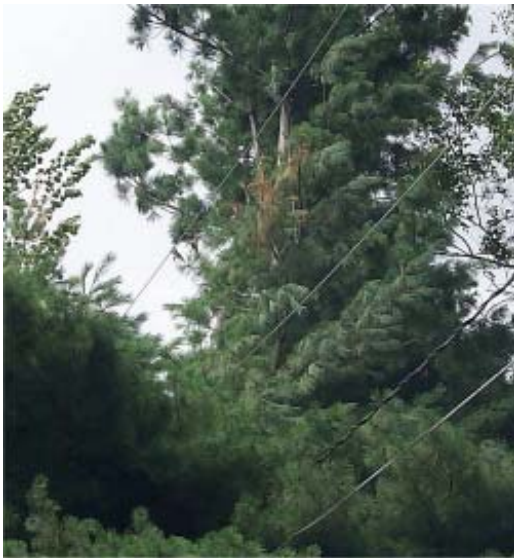
Photo 3

locations where trees were growing into or through the primary conductor. Almost all of the tree growth was new with the limbs just into the primary (photos 3 & 4). Staff encourages IP&L to do hot spot tree trimming of this circuit to minimize future tree related outages. Before IP&L trims this circuit in 2004 Staff would expect the tree problems and associated outages to be appreciable. Staff also noted a deteriorated crossarm on a rural line tap (photo 5). Staff is pleased with the overall condition of this circuit but feels that mid-cycle tree trimming should be a priority.

Primary burning in evergreen tree

Rear lot Iris & Eaton St. Savanna

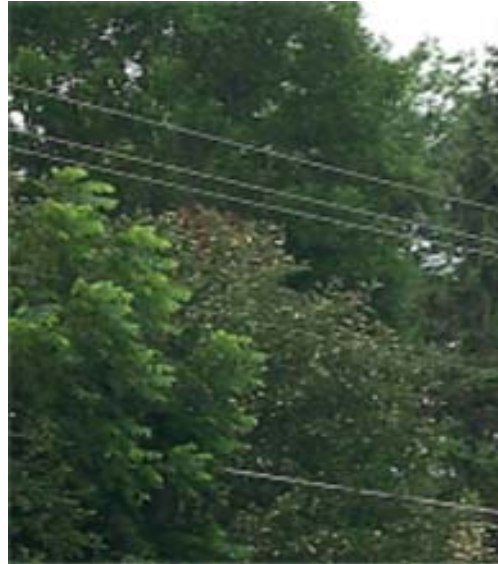
Photo 4

Top of trees burnt by primary

South of Doty Rd. on Rt. 84

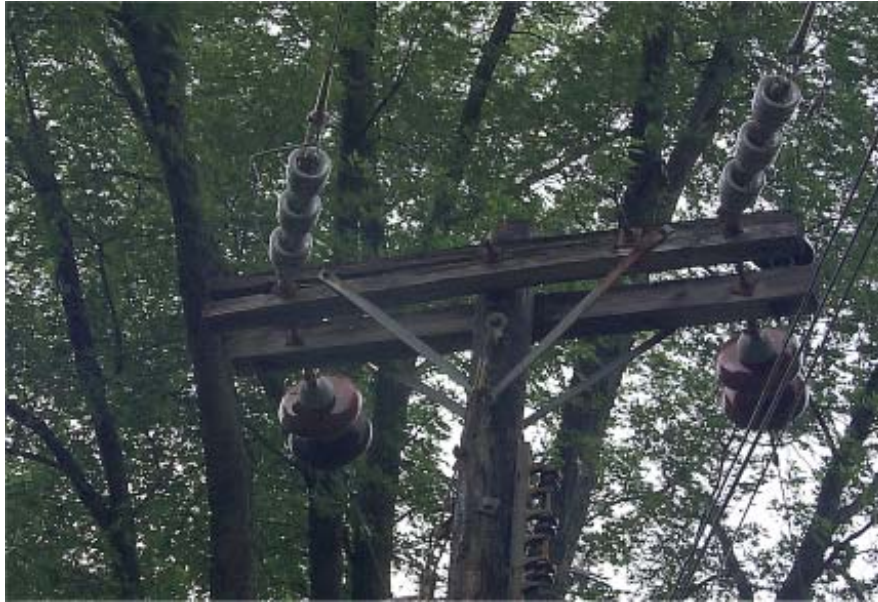
Photo 5

Damaged crossarm

East of Doty Cir on Doty Rd in Savanna
